Controlling Bad Control Levers

Defective manual control levers can let your M2 machine gun fire continously

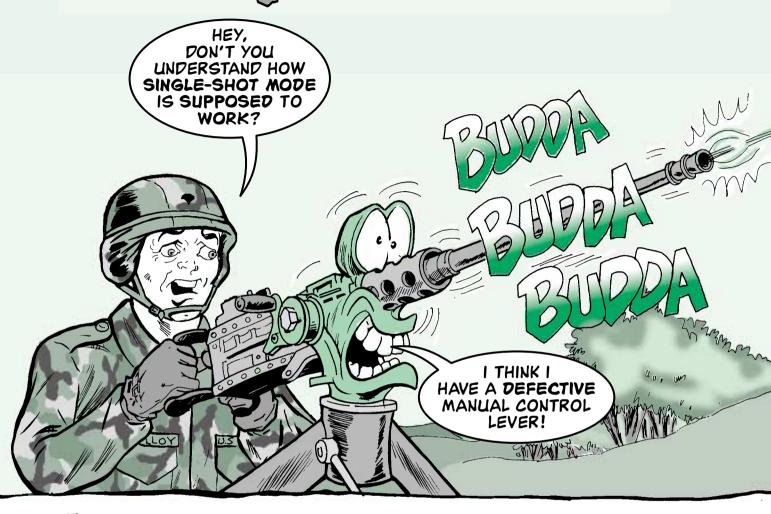
in the single shot mode when you want to fire only one round. That's dangerous and that's why armorers need to inspect their M2 levers now.

Remove the barrel, backplate, bolt, buffer, and barrel extension. Use a flashlight to look at the manual control lever inside the receiver. If the lever has rounded edges or shows signs of wear, get support to replace it with a new lever, NSN 3040-00-550-4060.

If the manual control lever is not worn, but has rounded edges, submit a quality deficiency report (QDR) either by faxing an SF 368 to (309) 782-6653, DSN 793-6653 or e-mail the information to:
